Testing of the Oztec/Rhodes Reinforcing Bar Shaker

The University of Tennessee
Department of Civil and Environmental Engineering
Knoxville, Tennessee

FINAL REPORT

August 15, 2003

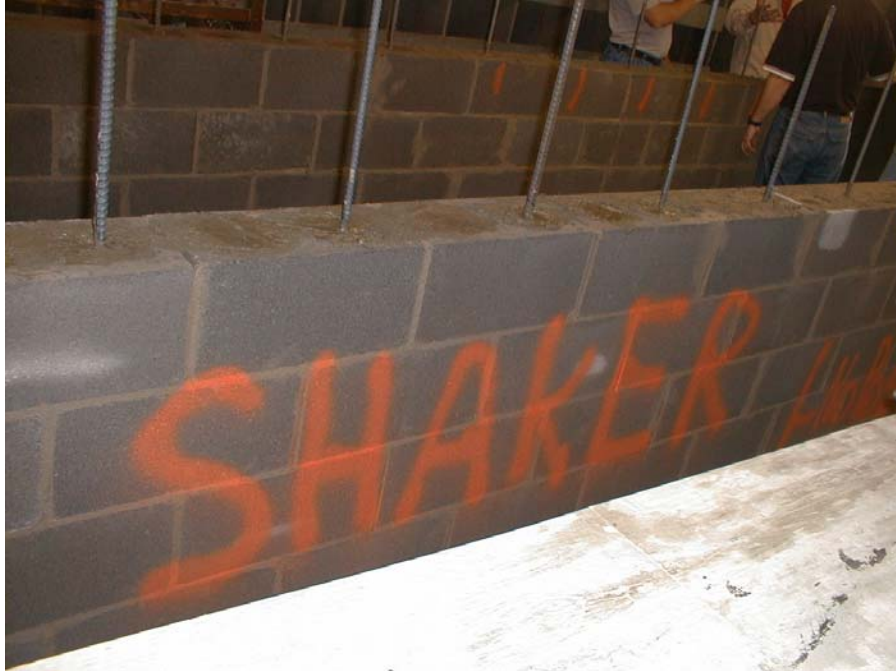
Figure 1. Completed wall prior to testing

Two masonry walls were constructed using standard 8 in. concrete block (CMU) units. Each wall was 3 ft – 4 in. high (5 courses) 14 ft – 8 in. long. Alternate cells contained a reinforcing bar. Five #4 Grade 60 bars and five #5 Grade 60 bars were placed in each wall. The wall was constructed with Type N masonry cement mortar by an experienced mason. The day after construction the walls were grouted with a coarse grout having a design strength of 3000 psi and a measured slump of 9 inches. The grout was consolidated in one wall using a pencil vibrator and in the other wall using a Oztec/Rhodes Rebar Shaker. Six cells in each wall (three with #4 and three with #5) were reconsolidated according to specification. The remaining bars were not reconsolidated in order to check the effects of a construction error of not reconsolidating as required. A picture of the completed wall is shown in Figure 1.

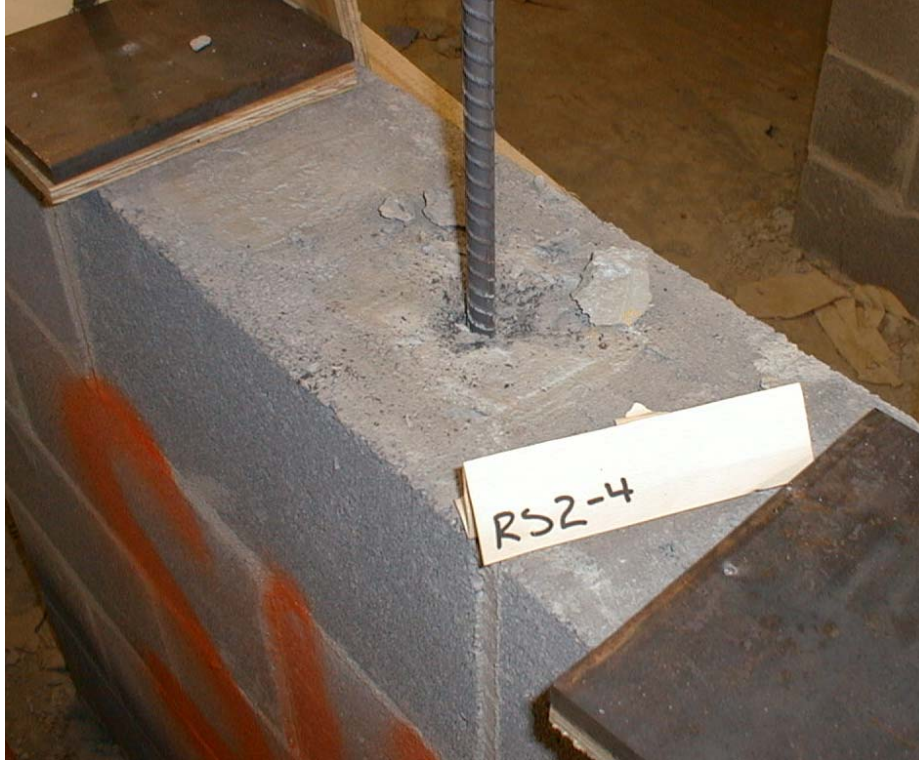
Figure 3. Typical small cone of grout that failed during testing of #4 bars

Complete results of the testing are given in Table 1. The #4 bars were tested until failure. In all cases the bar ruptured. Thus, the grout was sufficiently consolidated to develop the full failure strength of the bar. A small cone of grout about 0.5 in. deep would typically fail around the top of all #4 bars. This was most likely due to the yielding and elongation of the bar as it was being tested. A picture of this is shown in Figure 3.

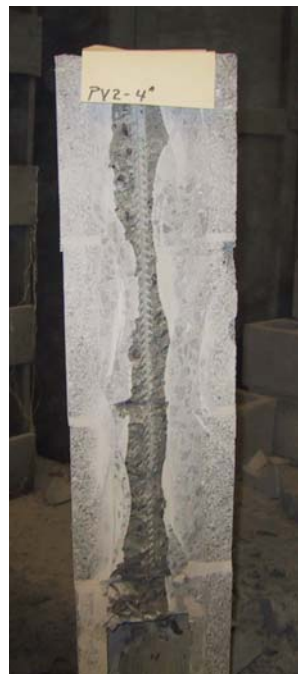
Figure 4. Wall cross-section with pencil vibrator consolidation

Figure 5. Wall cross-section with pencil vibrator consolidation

After the pullout testing was conducted, the walls were cut apart with a masonry saw to examine the condition of the interface between the grout and reinforcing bars and to inspect for any voids. Typical pictures from the pencil vibration wall are shown in Figures 4 and 5. Note that there are no voids, good bond between the grout and the masonry units, and the reinforcing bar indentations are clearly visible in the grout. Similar results were obtained when using the reinforcing bar vibrator. Figures 6 and 7 show the wall cross-section with a #5 bar. Figure 8 shows the wall cross-section with a #4 bar. There again are no voids, good bond between the grout and the masonry units, and the reinforcing bar indentations are clearly visible in the grout.

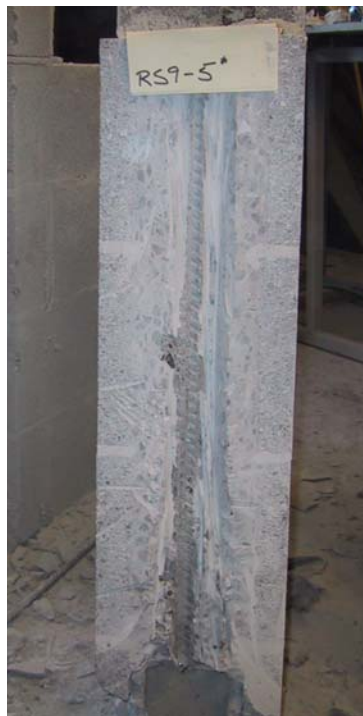
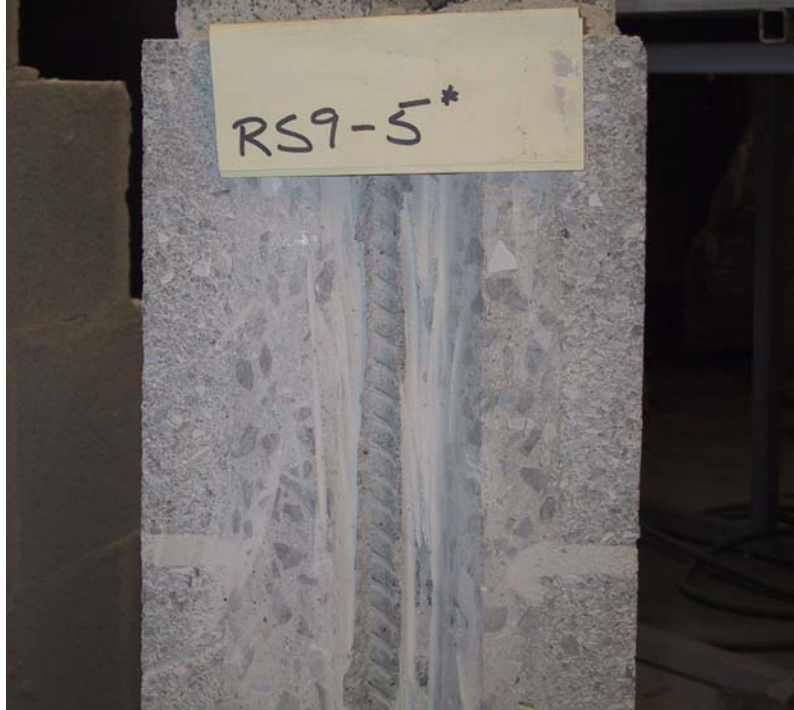
Figure 6. Wall cross-section with Oztec/Rhodes Rebar Shaker consolidation

Figure 7. Wall cross-section with Oztec/Rhodes Rebar Shaker consolidation

Figure 8. Wall cross-section with Oztec/Rhodes Rebar Shaker consolidation

No noticeable difference was observed in either the pullout strength of the bars or the condition of the grout when the grout was destructively examined between the cells that were consolidated only once, and those cells that were reconsolidated. This shows the effectiveness of the Oztec/Rhodes Rebar Shaker in that proper consolidation was achieved without reconsolidation. We do recommend that the current specifications be followed and that the grout be reconsolidated, but the Oztec/Rhodes Rebar Shaker performs the same as the pencil vibrator should reconsolidation be mistakenly omitted.
